## Common Problems for Small Dams with Conduits as the Principle Spillway

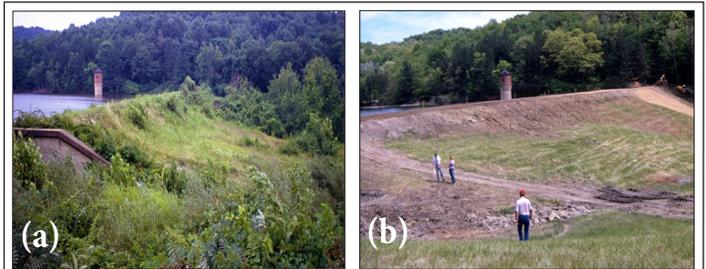
(a) Embankments covered with trees and brush makes inspection difficult. (b) Cleared of trees and brush, this embankment is much easier to inspect, but needs a good vegetal cover.

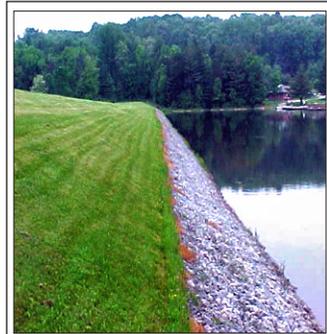
This slope is well maintained with rock riprap along the shoreline.

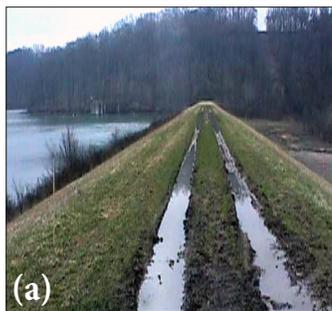
(a) Embankment crests with vehicle ruts will collect water and weaken the embankment. (b) Crest beginning to overtop in low area. This could lead to erosion and failure of the dam.

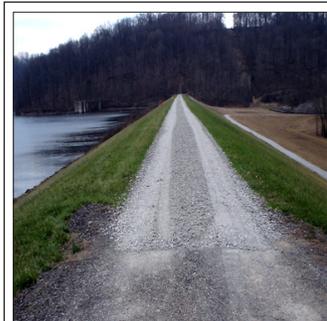
Crest with a good cover that will reduce the effects of vehicular traffic.

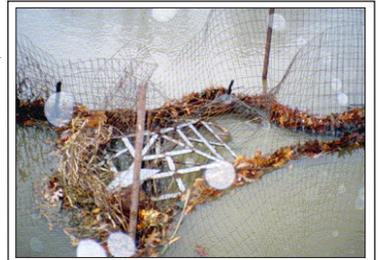
Trashracks with openings that are too small cause leaves to clog the inlet – fencing should not be used.

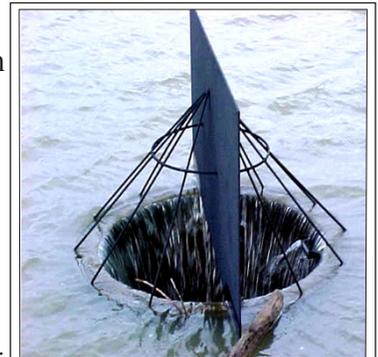
Trashracks with properly sized openings will pass smaller debris and stop larger items.

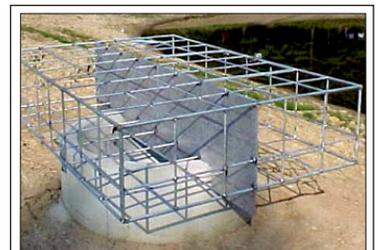
A trashrack with properly sized openings, large surface area and an anti-vortex plate will likely perform best.

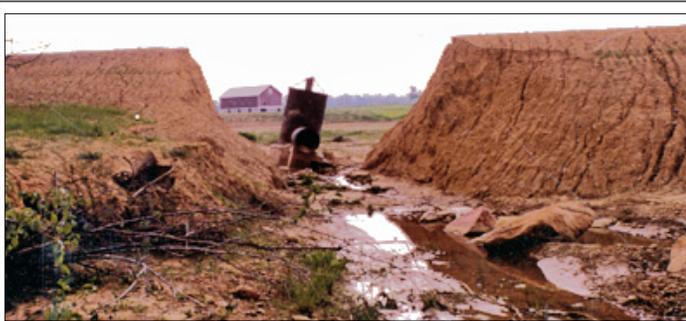
This Dam failed from seepage along the principal spillway.

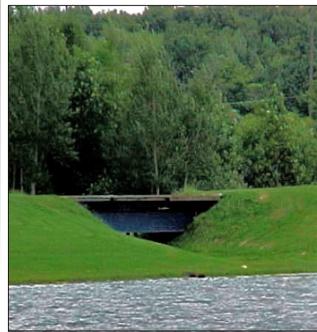
This bridge blocks much of the spillway, reducing its ability to convey water.

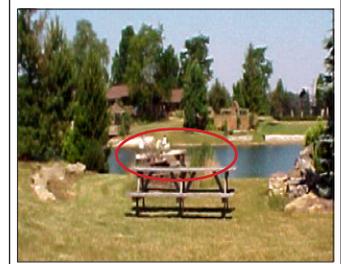
Landscaping, directly behind the table, is obstructing the spillway reducing the capacity to convey water. It also can collect debris, further diminishing spillway capacity.

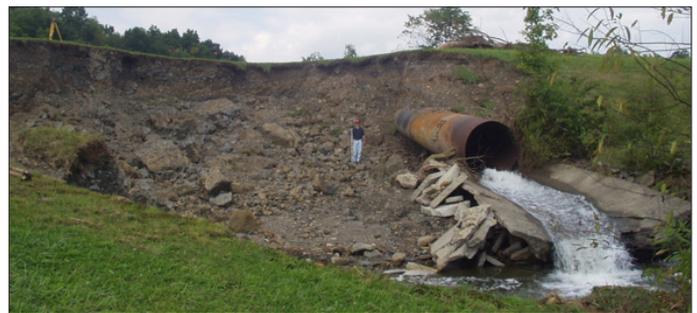
Severe erosion and near failure of the dam (2004) resulted after the principal spillway plugged during a storm. The dam did not have an emergency spillway. The dam was removed one week later.

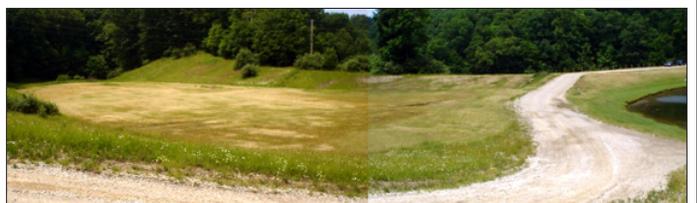
This open-channel emergency spillway is clear of trees, brush and other obstructions. Also note the good grass cover.
