Middle Cuyahoga River Watershed Action Plan

December, 2012

Prepared By
Maia Peck
Middle Cuyahoga River Watershed Coordinator
Northeast Ohio Four County Regional Planning and Development Organization
180 E. South St.
Akron, OH 44311
330-252-0337
mpeck@nefcoplanning.org

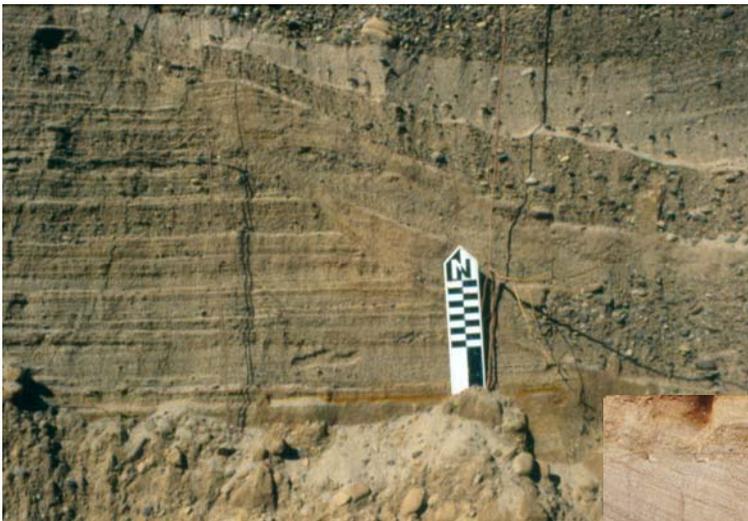
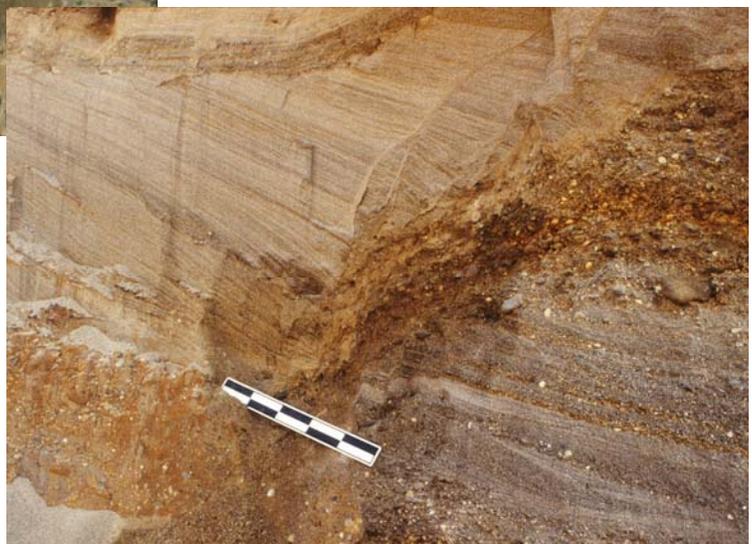
Figure 4a-1
Glacial Deposits: Till and Outwash

Typical till in northeast Ohio has a high proportion of clay, with silt, gravel, cobbles, and boulders mixed in.
Source: J Szabo, University of Akron.

Glacial outwash is often sandy or gravelly. It typically exhibits horizontal or dipping layers, and the sediment is well-sorted by size, with deposits of finer or coarser grains reflecting different flow conditions. *Photo source: J. Peck, University of Akron Geology Dept.*

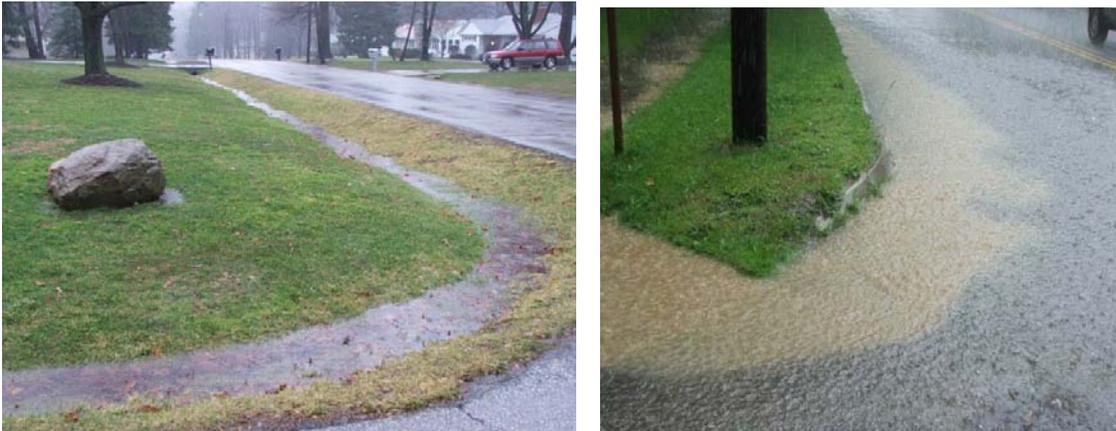
Figure 4d-11
New Headwater Streams

The new urban headwater streams found in the developed areas contribute volume but do not provide any treatment provided by undisturbed riparian landscapes.

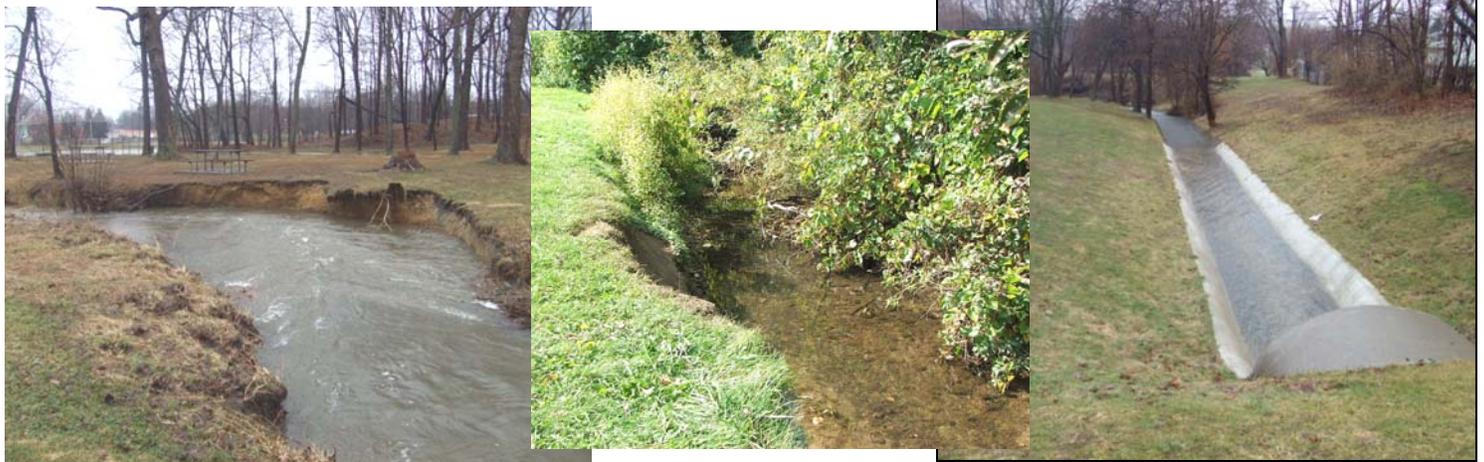
MS 280, 270 Kelsey Creek in Kennedy Park lacks a functional riparian corridor and is eroding its banks, partially due to excess stormwater from altered stream corridors and impervious surfaces in neighborhoods. The sediment and channel erosion degrade the stream habitat. Many streams in the Main Stem subwatershed are altered. Spring, 2011, Summer, 2010.

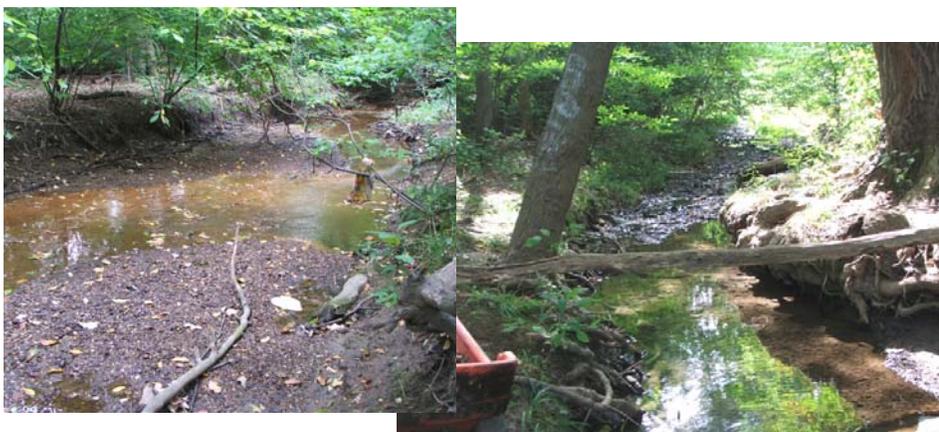
MS 250, 260 Kelsey Creek is generally low-gradient and is most intact within woods.. (Center) Even a low-gradient portion like this through Galt Park is incising, showing evidence of overloading. Summer, 2010.

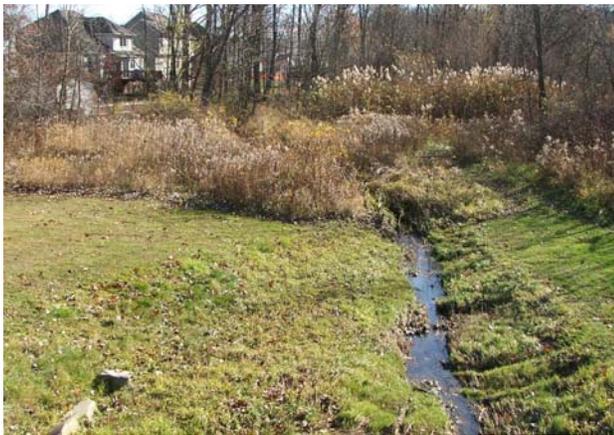
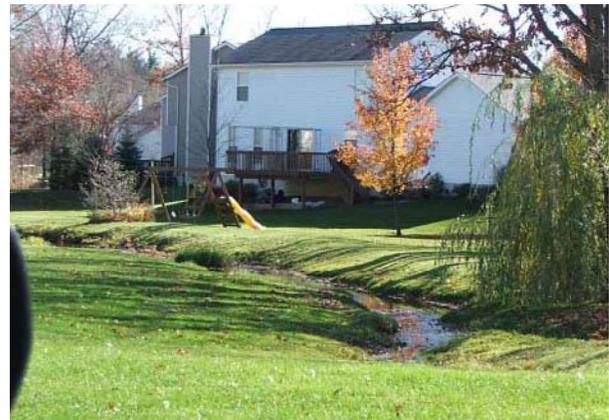
F-320, F330 Remaining stream in developed area, Edgewater neighborhood. In areas like these, enhancing the narrow riparian area with shrubs, tall grasses, or trees, could reduce the risk of erosion. Nov., 2009.

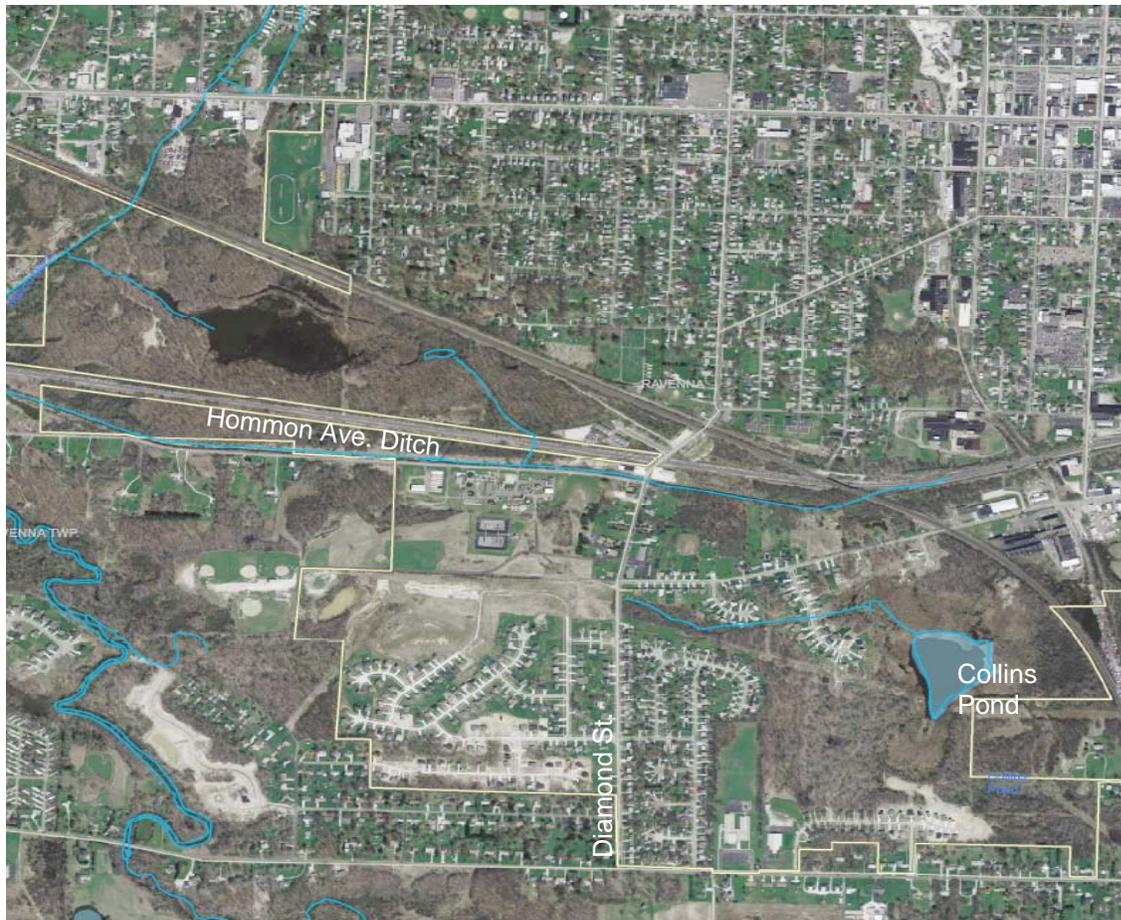
Collins Pond and Hommon Ave. Ditch

Collins Pond (highlighted in blue in lower right). Neighbors have noted flooding problems. Collins Pond outlet is culverted west of Diamond St. (see previous page). The pond is surrounded by wetlands and “D” (very poorly draining) soils, see photos below. The pond is also largely surrounded by impervious surfaces, which increases the runoff load to the pond and outlet channel. Hommon Ave. Ditch is in a channel between a road, the wastewater treatment plant, and a high tension utility line. It appears that toward the downstream end of the ditch, the embankment is eroding, threatening the road. The pond in the left center of the picture has increased in size and wetness since the early 1900s. Possible measures to consider, in addition to the City’s riparian setback, include setting aside land through easements, reducing or storing runoff from impervious surfaces, daylighting the outlet and restoring some flood storage . Source: Ohio DNR, PCRPC, 2006 Photo.

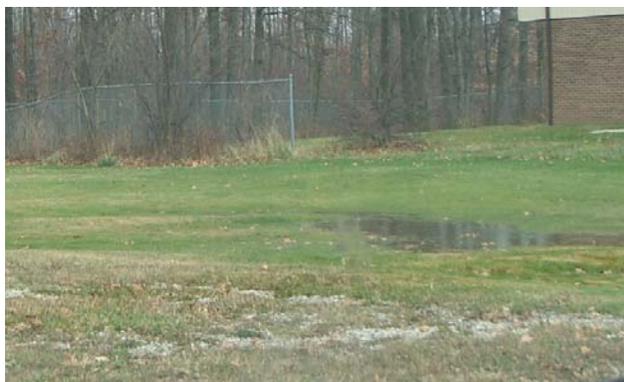
B-170 Ponding in poorly draining soils near Collins Pond, Fox Run Rd., Nov. 2009.
