# **Ground Water Induced Flooding in the Bellevue Ohio Area Spring and Summer 2008**

**ODNR Division of Water Technical Report of Investigation 2009-1**

**January 2009**

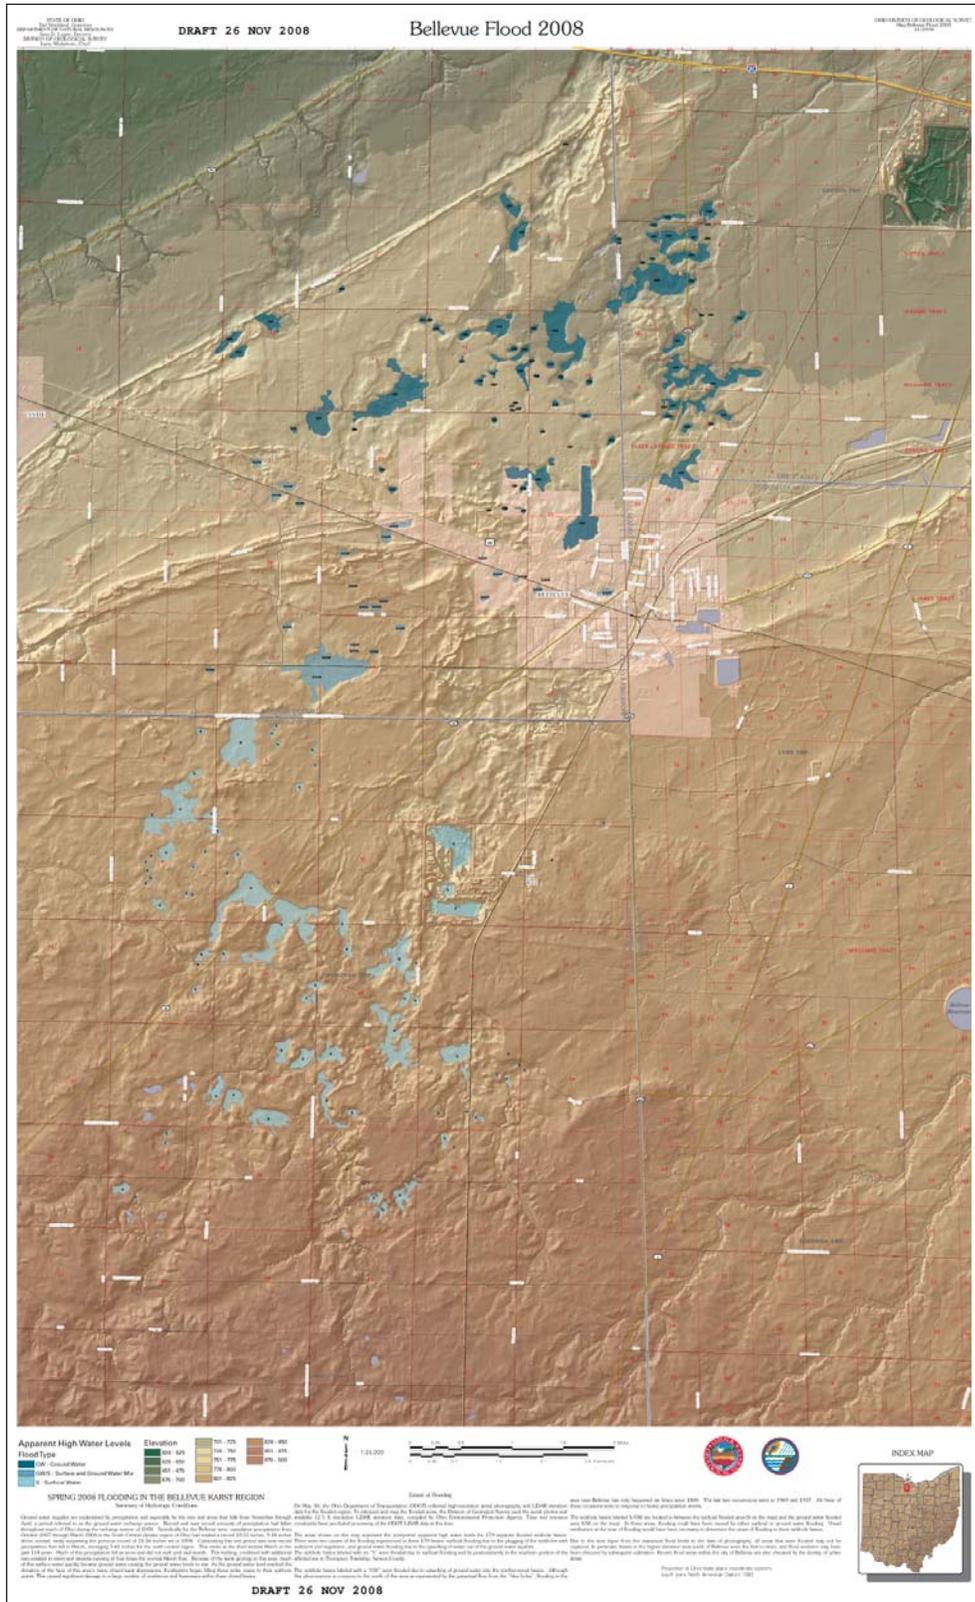
A draft, page-size version of the Division of Geological Survey's map, EG-5, Bellevue Flood 2008, by Richard R. Pavey and Donovan M. Powers. Currently under preparation and review.
