Mad River Watershed Strategic Plan

prepared by Anne Coburn-Griffis,
ODNR/DNAP Ohio Scenic Rivers Program,
for the Mad River Watershed Strategic Plan Joint Board of Supervisors

EXECUTIVE SUMMARY

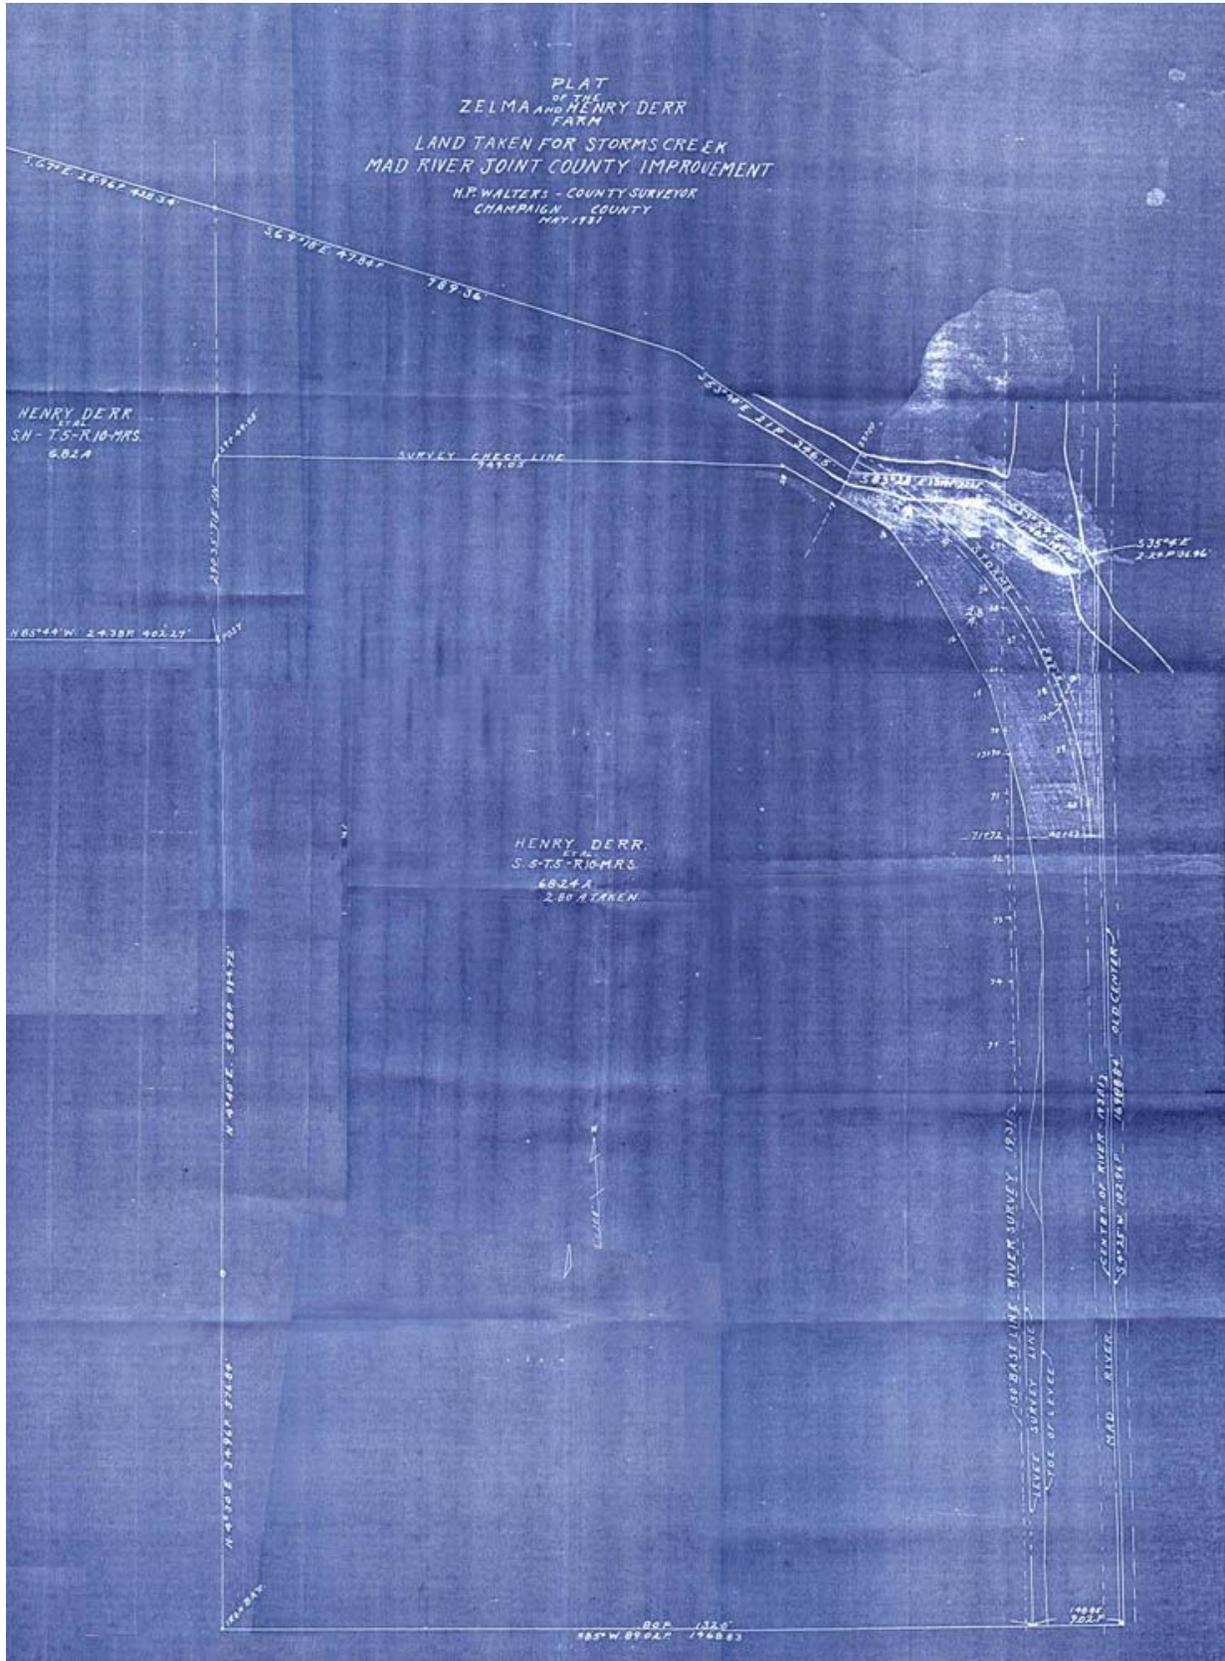
Figure 5. Blueprint of Storms Creek channelization project, May 1931. (Source: Champaign County Engineer)

In April of 1913, three days of heavy rain pushed the Mad River out of its banks to flood the entire area. The resultant destruction incited local governments to demand action that would ensure that such a calamitous event would never reoccur. As a consequence, people in the area constructed levees and channelized the river and many of its tributaries (see Figure 5.) to control the flooding. These acts permanently altered the natural processes of the watershed, the aquatic environment, and the dynamics of stream flow. Further, dredging of the stream, while significantly contributing to a greater depth and width of the river, provided material to raise the level of the river's banks, creating a levee of sorts, which was stabilized with willow shoots, according to a 1922 blueprint (see Figure 6.). The modification of the Mad River created a straight, artificial ditch without pools or riffles. Dredging changed the dynamics of stream flow by

increasing the velocity and probably the amount of ground water discharge, especially in the Logan and Champaign County area. Today, the base flow rate produces highly oxygenated conditions. This groundwater influence makes the Mad River unique in this part of Ohio as a coldwater stream, the largest in the State of Ohio, which only rarely exceeds 70 degrees Fahrenheit during the summer.

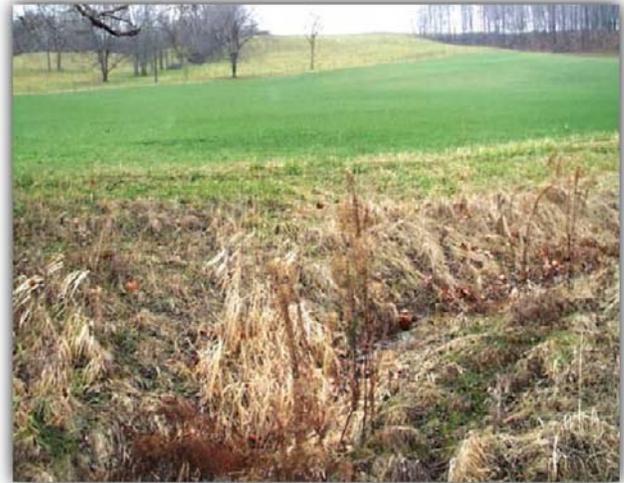
Winter Cover Crops established along Buck Creek (Champaign County)

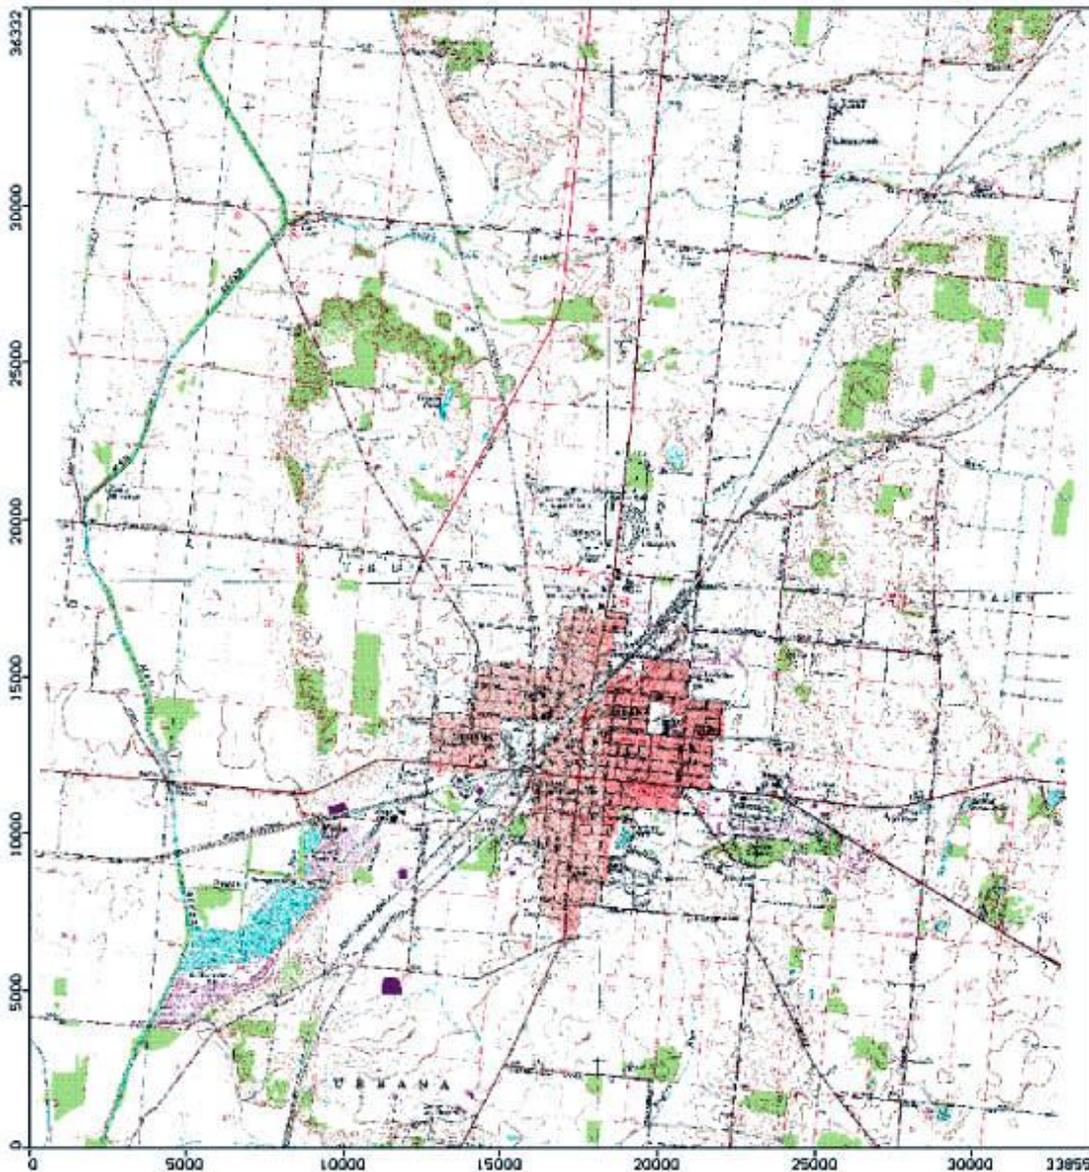
A ground water flow model was used to simulate ground water flow and the interaction with surface drainage. The ground water flow model chosen for this study was MODFLOW (McDonald and Harbaugh, 1984). Modflow is a three-dimensional finite difference flow model. Contained in the Visual Modflow package is the module MODPATH. MODPATH is a post-processing package that calculates particle paths and generates graphs. MODPATH is for backward particle tracking to illustrate the pathway from a contaminated well to the recharge area and contaminant source. It can also calculate the travel time for contaminant transport. The main purpose for constructing a ground water flow model was to use MODPATH particle tracking software to determine the source of recharge to nitrate contaminated wells.

-Source: "The Relationship between Land Use, Ground Water Flow and Non-Point Source Contamination in the Upper Mad River Watershed", Wayne Jones of Ohio Department of Natural Resources (ODNR), Division of Water (DOW)

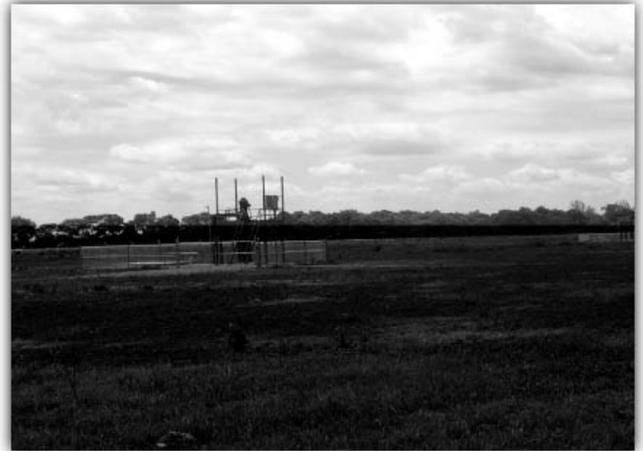
North SR 29 Wellfield (photo by Jennifer Ganson)

North Sr 29 Wellfield: The City purchased approximately 30 acres of the Stadler property adjacent to the Mad River and has obtained a conservation easement for the approximately 10 acres

which includes the Mad River and its banks. This allows for the 300 foot isolation radius required for up to 4 production wells, as well as about 3 acres near SR 29 for a treatment facility if required.

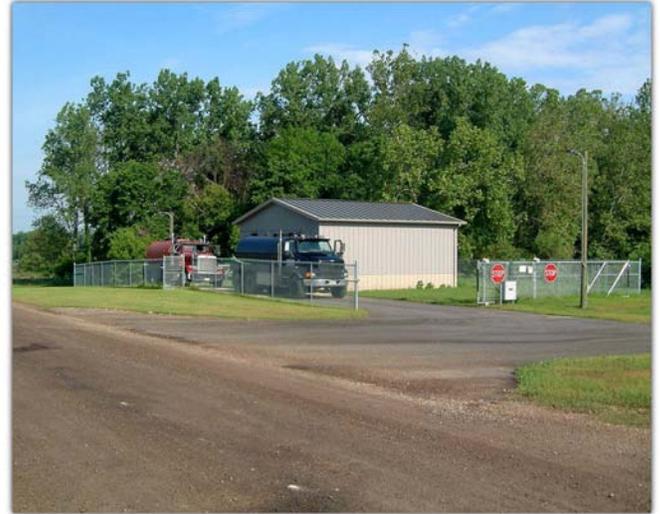
City of Urbana septage receiving facility

With small capital expenditures in the past 15 years, the Urbana WPCF has started a new design and upgrade study in early 2006. With small capital expenditures in the past 15 years, the Urbana WPCF designed and installed a new state of the art microwave sludge drying system. The unit was installed in late 2008 and completed in 2009. The Burch Bio-Wave unit produces a Class A material with a 90% reduction in volume of sludge. This end product can be land applied to farm ground at agronomic rates or other valuable reuses that the City is looking at. Along with the microwave project in 2008, the Urbana WPCF completed a septage receiving facility that accepts multiple county household sewage. This facility is a 24 hour a day 7 day a week facility that currently has 9 registered septage haulers from 3 counties. With many new

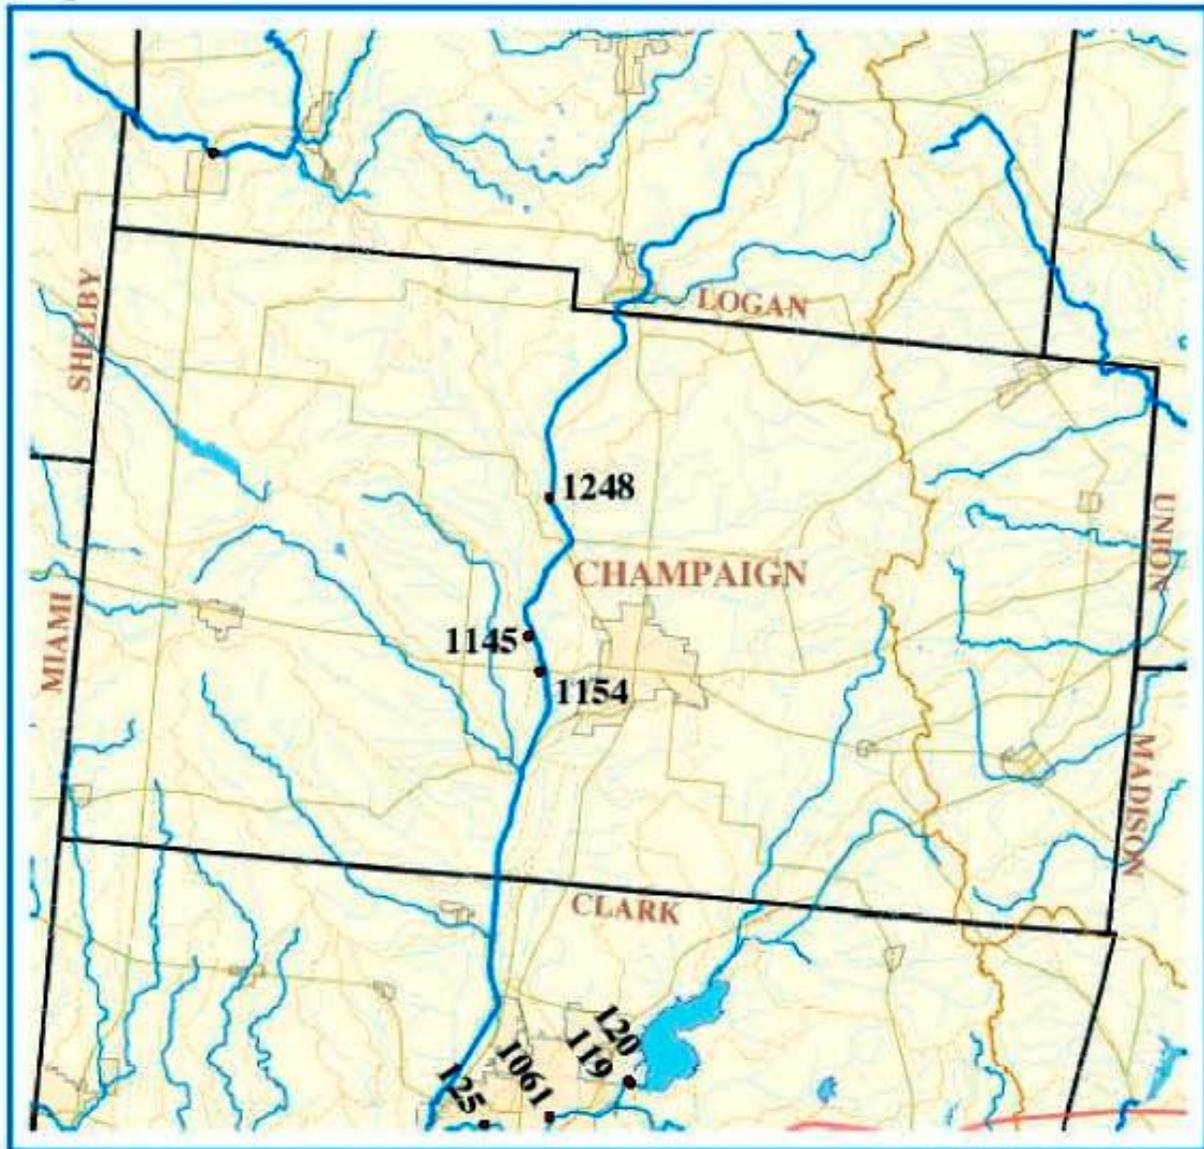
CHAMPAIGN COUNTY LOWHEAD DAMS

- Lowhead Dam
- Streams
- Interstates
- Primary Roads
- Major Watersheds
- Watersheds

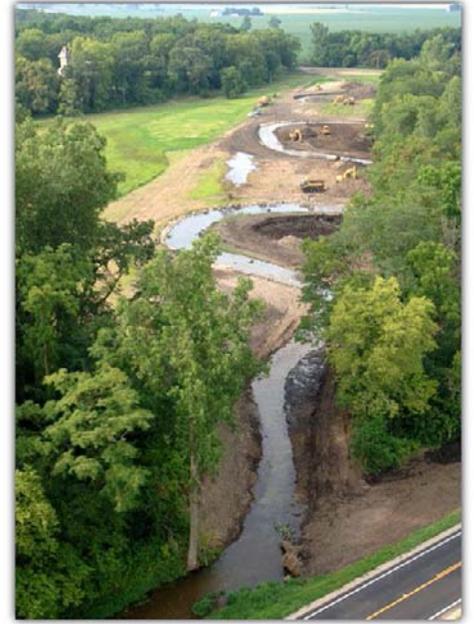
Macochee Creek Restoration Project (Source: ODNR)

Past and Present Conservation Efforts: A 1,500 foot section of the Macochee Creek and its floodplain at Logan County's Piatt Castles was restored in 2008. During the Macochee Creek restoration project, environmental contractors studied the soil, water, and topography of the area to determine the best spot for the new creek to flow. They then dug a new channel for the water to run through and redirected the creek into it. The new route is meandering to mimic what would have been the creek's original condition. The contractors also planted trees, grasses, and forbs in the floodplain area around the creek to reduce stream bank erosion and to act as natural filters to improve water quality.

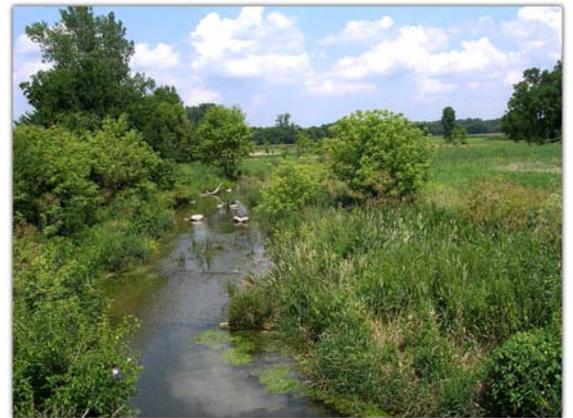
Macochee Creek Restoration Project in 2009

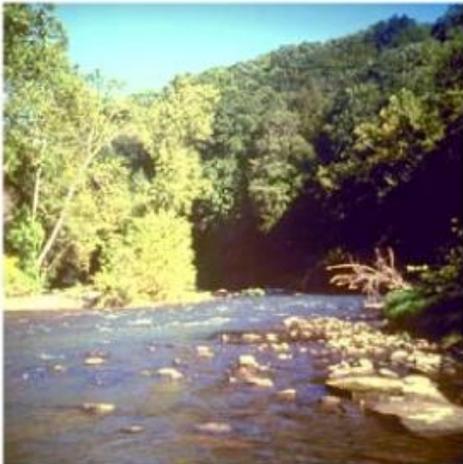
Good Stream Habitat

- Major Downstream Exports:**
- I. Desirable Biomass (e.g., fish, plants, birds, mammals, sensitive species)**
 - II. Low Sediment Delivery**
 - III. Water Quality Suitable for ALL Uses**
